Maple Grove Township T 2 N R 7 W Barry County Michigan

Section 6 08-10-006- Scale 1"= 400'

This tax map was compiled for tax administration purposes from county and township records. It does not represent a land survey.
Barry County Land Information Services
220 West State Street, Hastings MI 49058
(269) 945-1292 or <http://www.barrycounty.org/>

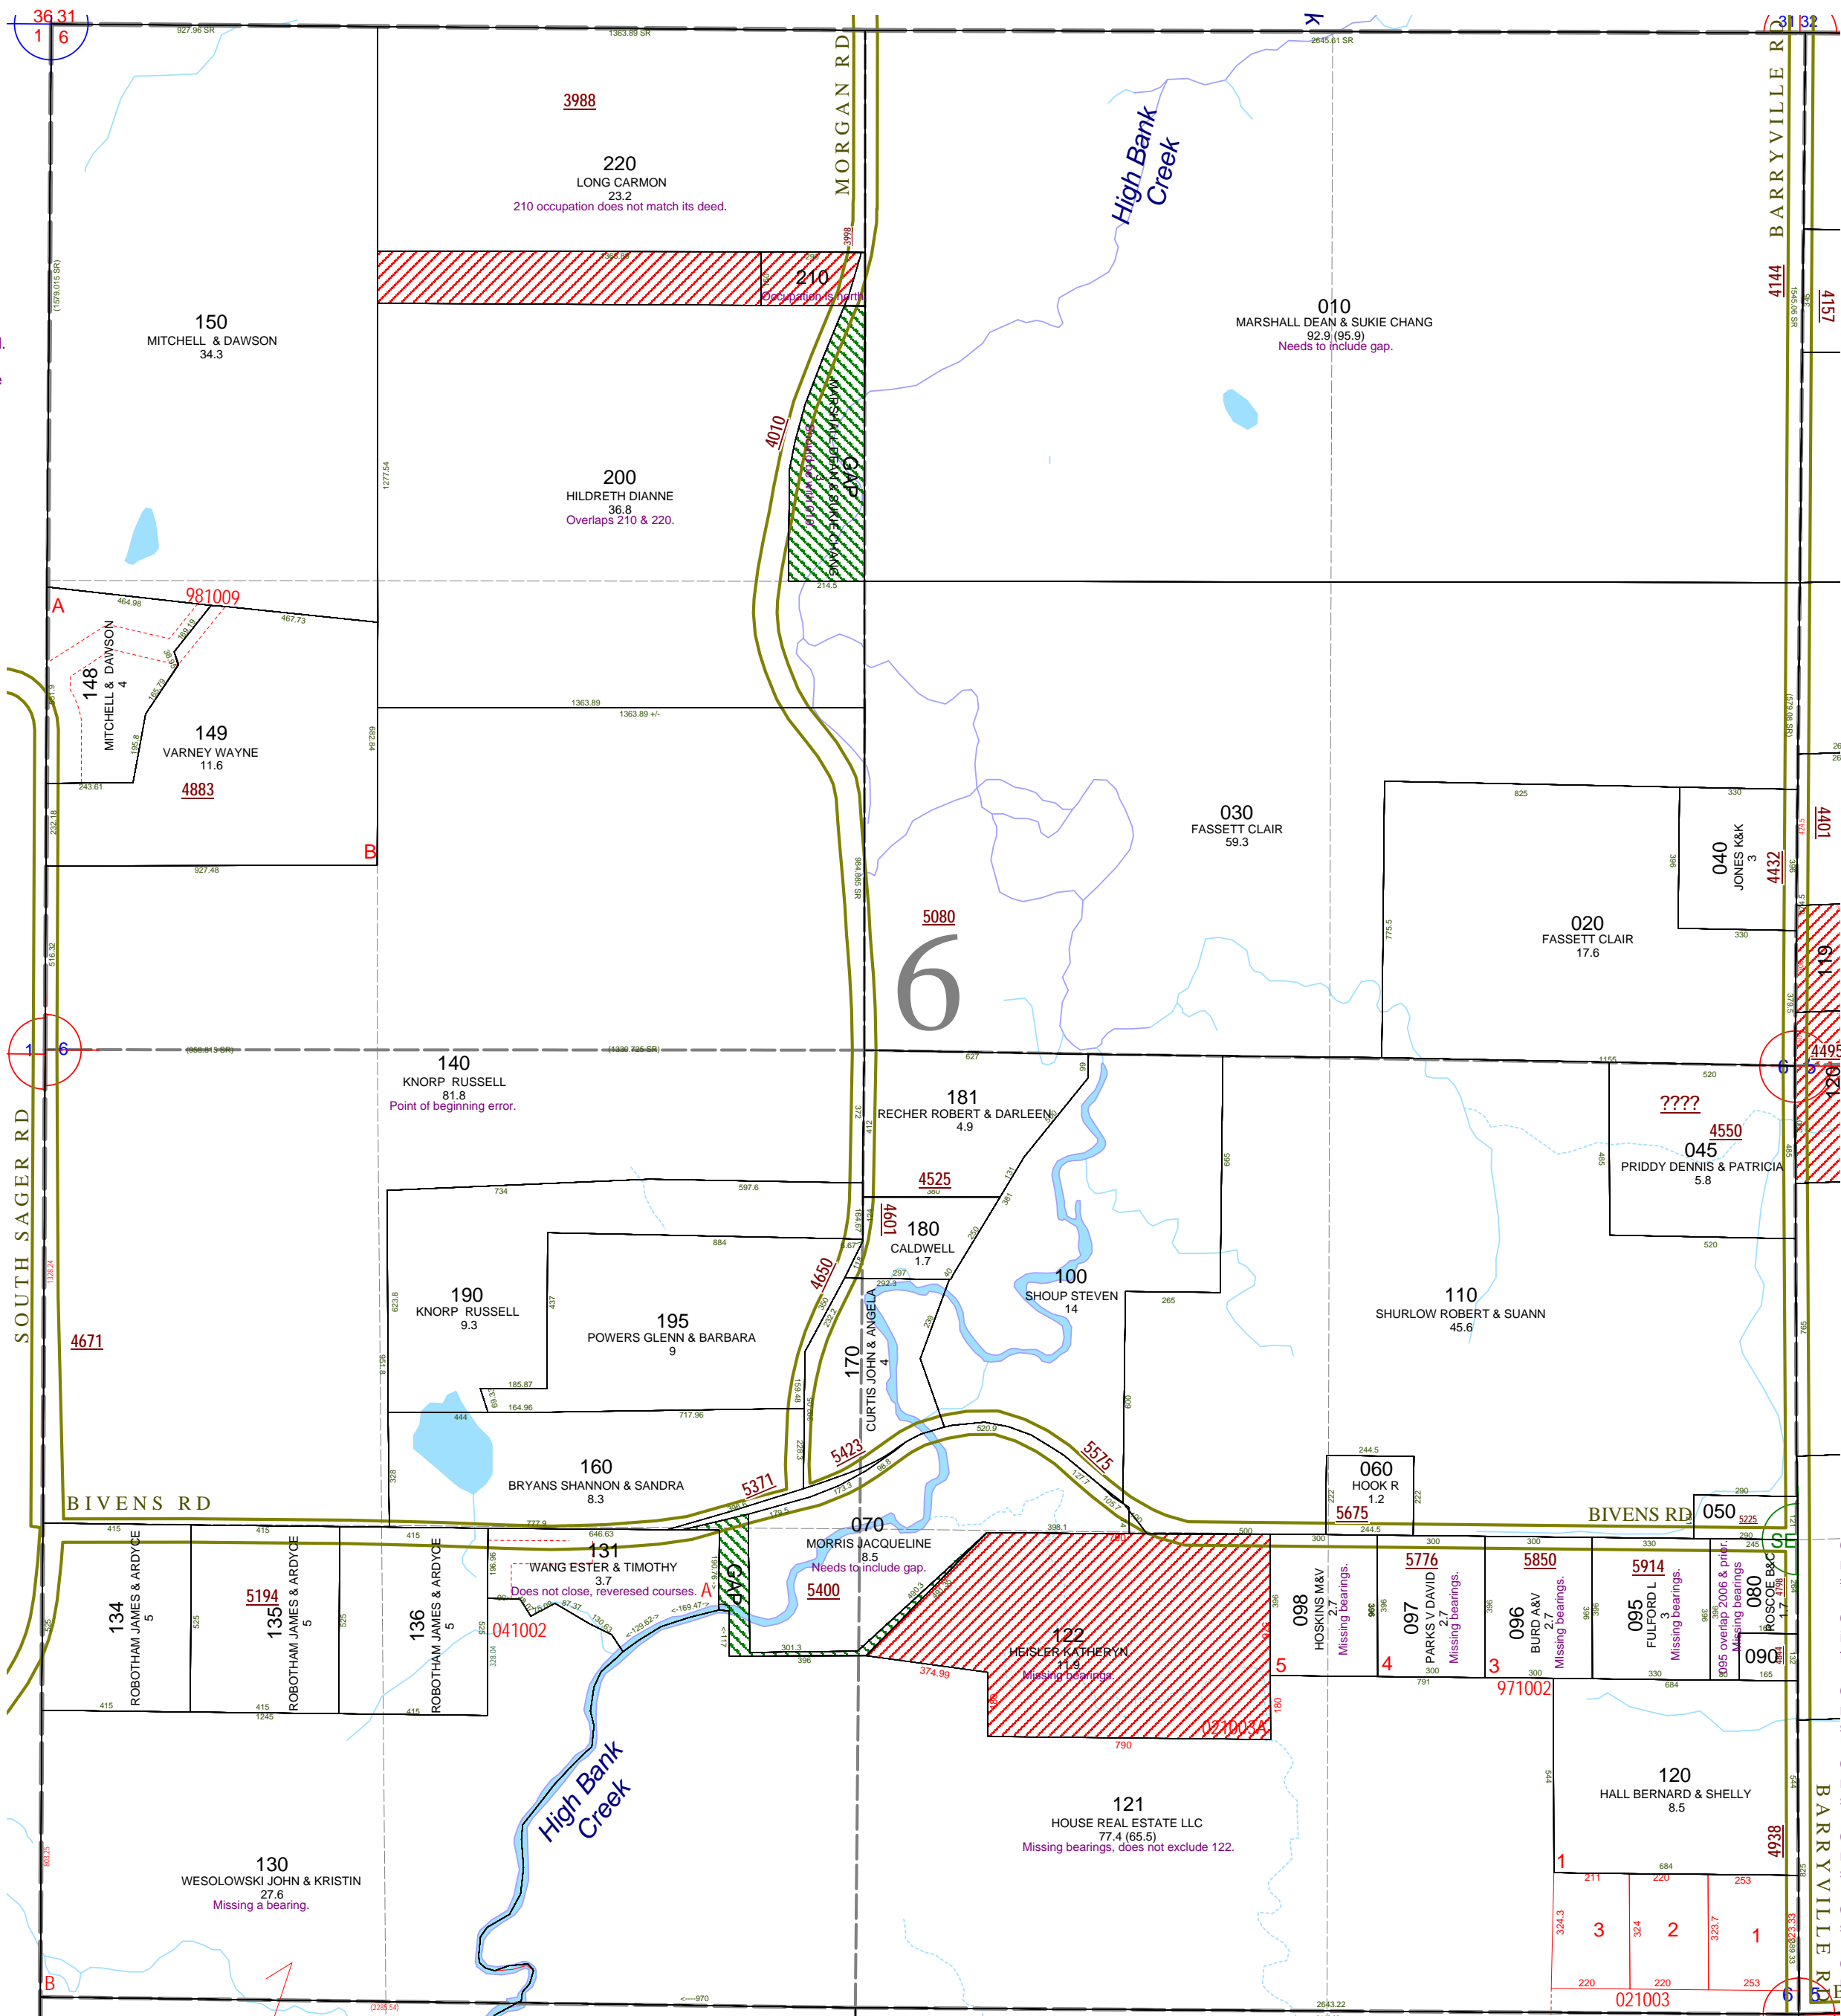
All dimensions are from tax roll unless noted below.
D = deeded M or S = surveyed
SR = Surveyor's Record prior to 1915
GLO = Government Land Office circa. 1830

08-10-006-210-00 should not include property east of Morgan Rd and the assessed structure of 3998 Morgan Rd isn't actually on the property. The original deed has the wrong point of beginning. The real point of beginning should be a point 638.88ft south of N 1/4 post, but that is not what they were deeded.

08-10-006-220-00 should exclude 210 as occupied at a point starting 638.88 feet south of the north line as recorded in the surveyor's record.

08-10-006-200-00 overlaps 210-00 & 220-00 (see L.265-456 & 351-262 for original partitions)

08-10-006-140-00 has an error in point of beginning which should be W 1/4 post.

08-10-006-070-00 needs to include gap parcel to its west.

08-10-006-131-00 does not close because it has a couple of reversed courses. See split #041002.

08-10-006-130-00 is missing a course bearing See split #041002.

08-10-006-010-00 needs to include gap parcel to the west as deeded in R#1118795 to Marshall.

08-10-006-080-00 is missing course bearings and needs to be described as surveyed for split #971002.

08-10-006-095-00 is missing course bearings and it has a point of beginning error, correction reads from survey for #971002.

08-10-006-096-00 is missing course bearings and needs to be described as surveyed for parcel 3 of split #971002.

08-10-006-097-00 is missing course bearings and needs to be described as surveyed for parcel 4 of split #971002.

08-10-006-098-00 is missing course bearings and needs to be described as surveyed for parcel 5 of split #971002.

08-10-006-122-00 is missing course bearings. See split# 021003 for correction.

08-10-006-121-00 is missing course bearings and needs to exclude split to 122.
