Carlton Township
T 4 N R 8 W
Barry County
Michigan

Section 13
08-04-013-
Scale 1"= 400'

This tax map was compiled for tax administration purposes from county and township records. It does not represent a land survey.
Barry County Land Information Services
220 West State Street, Hastings MI 49058
(269) 945-1292 or <http://www.barrycounty.org/>

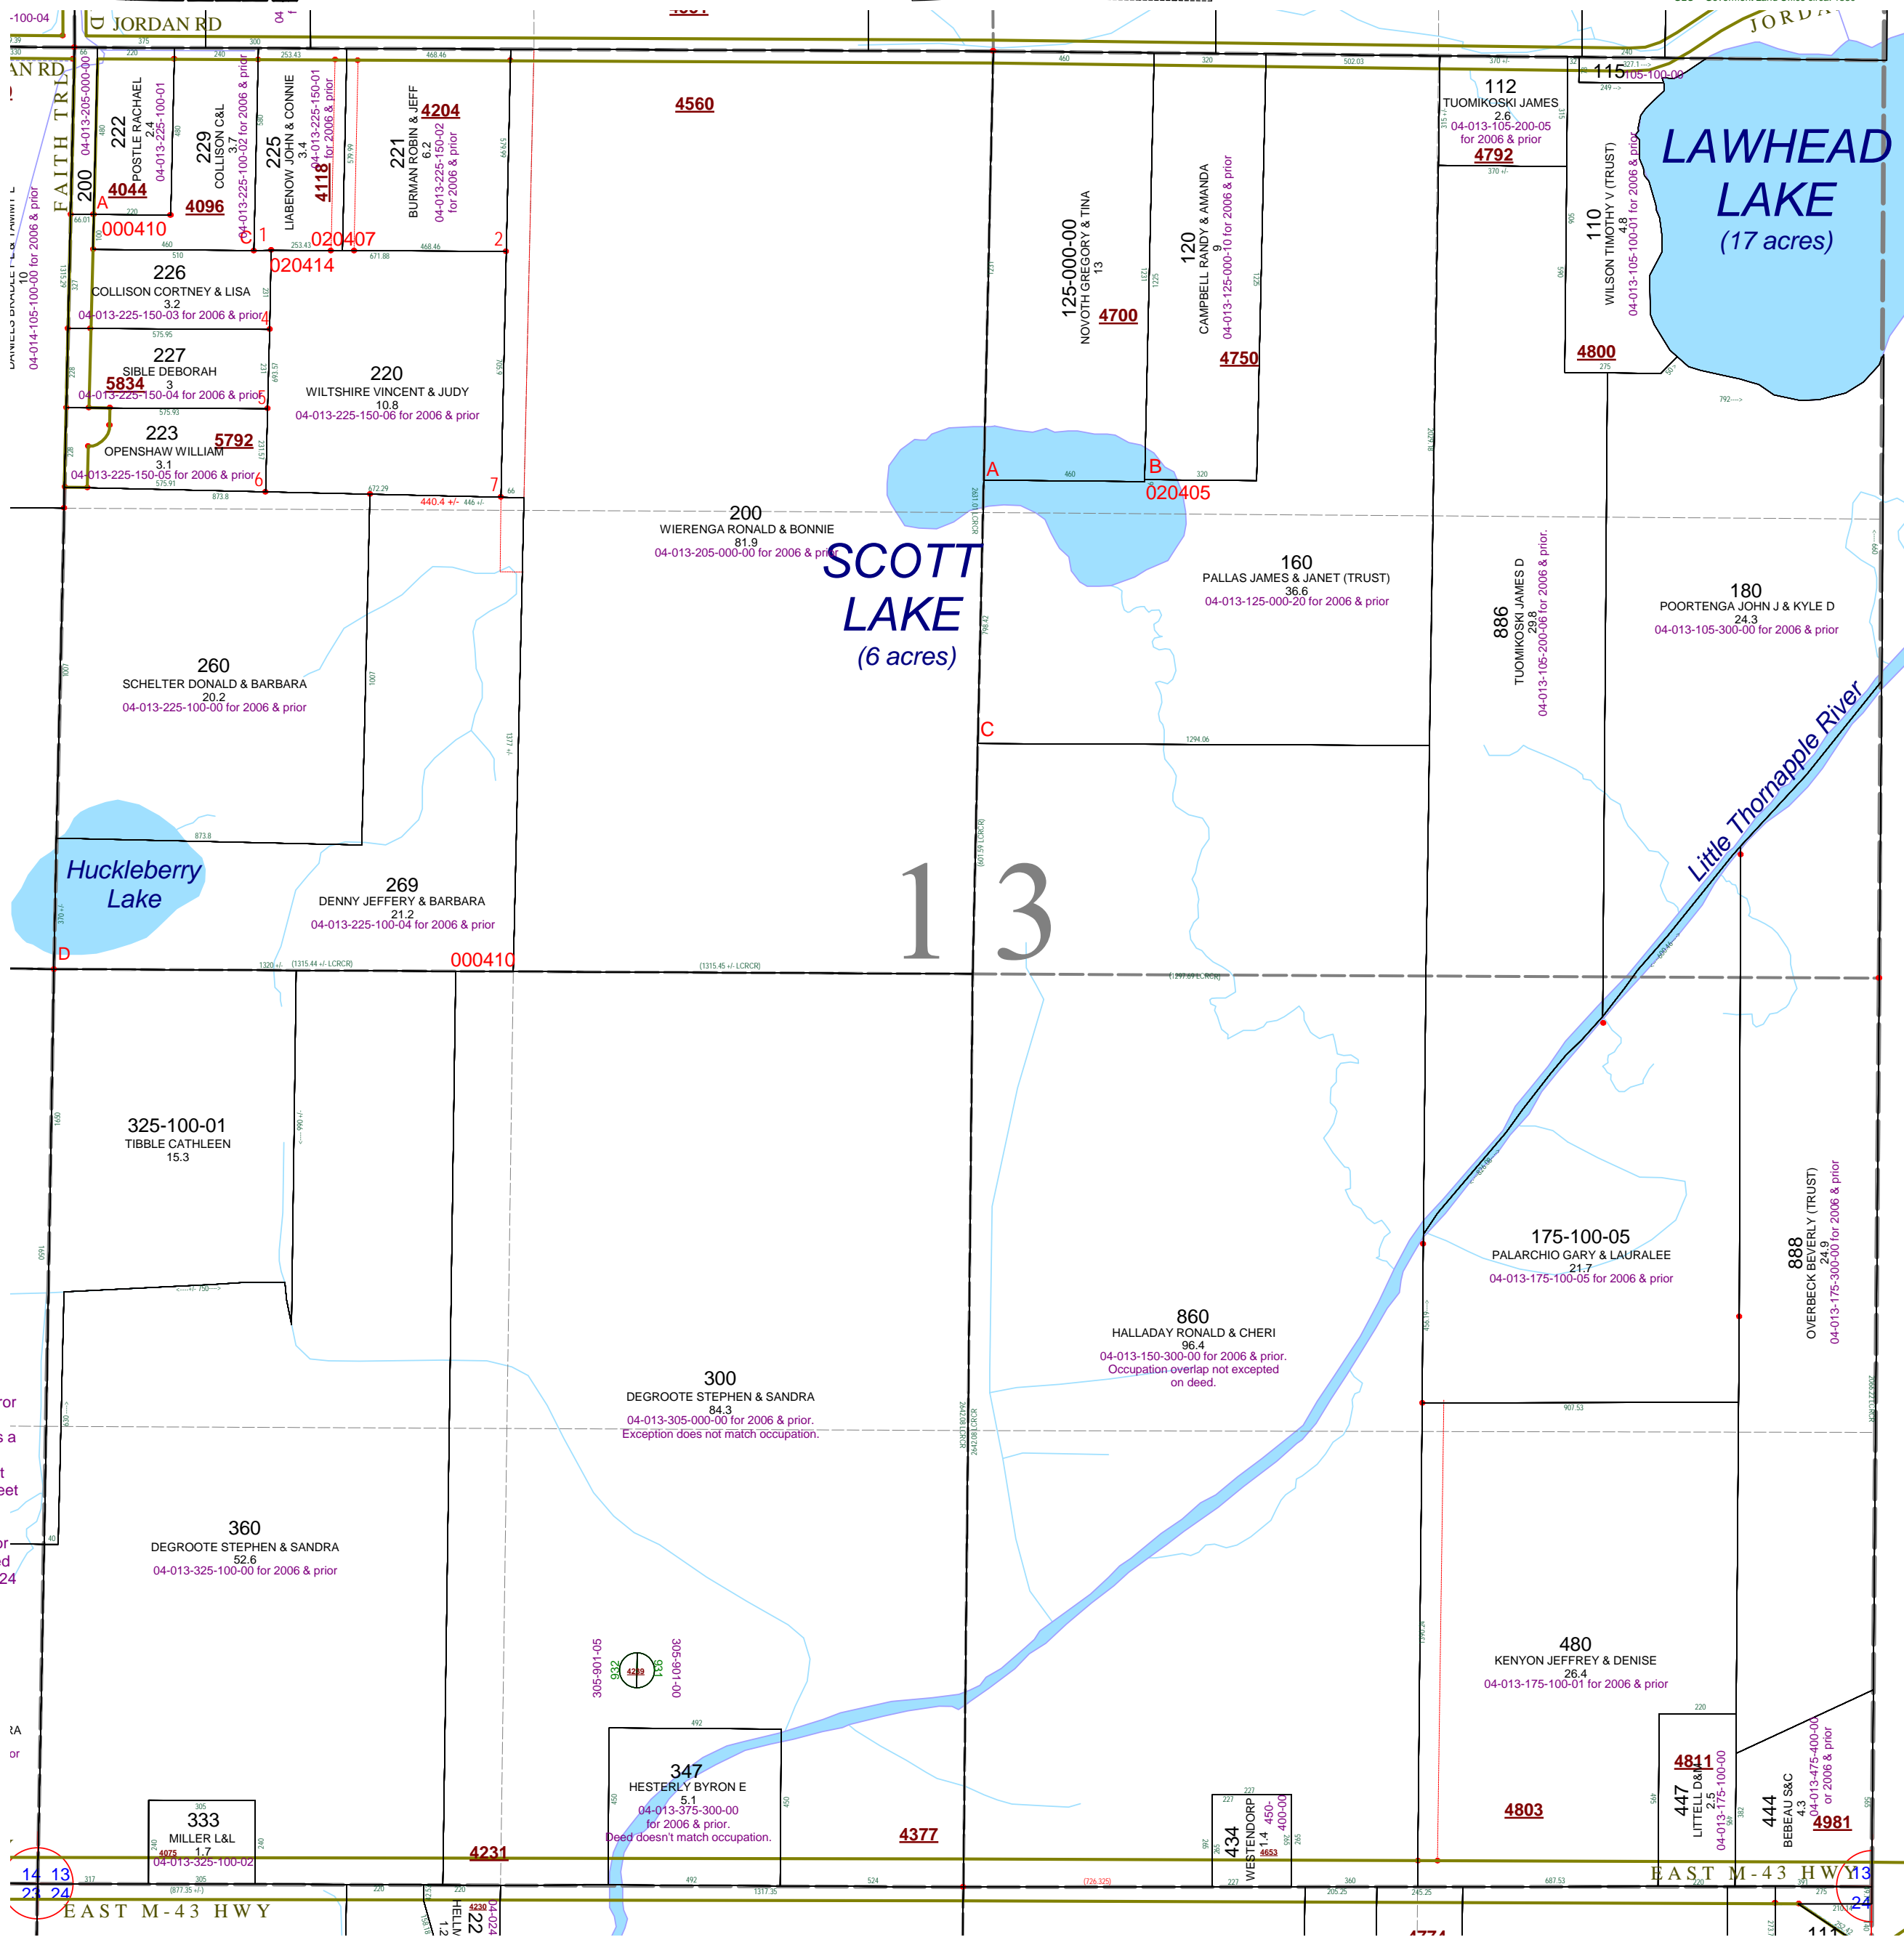
08-04-013-300-00 has a point of occupation error on the deed for grantor's exception. The exception for Hesterly on deed to Degroote has a point of beginning listed at 524 feet west of SE corner of section. The aerial would suggest that the figure was probably supposed to be 2524 feet west of SE corner of section instead.

08-04-013-347-00 has a point of beginning error on the deed. The exception for Hesterly on deed to Degroote has a point of beginning listed at 524 feet west of SE corner of section. The aerial would suggest that figure was probably supposed to be 2524 feet west of SE corner of section instead.

08-04-013-860-00 needs to exclude Hesterly/347 as occupied, because exception to Degroote's deed was in error. Because of this error it was not caught on deed to Halladay. My best guess based on measurement off aerial photo would have the 524 feet to point of beginning as 2524 feet instead. Hesterly's garage and occupation overlap 860 by at 50 feet of mowed lawn and 15 feet of building encroachment.
